26 07 01

Supersedes Technical Service Bulletin Group 26 number 05-03 dated July 20, 2005 due to addition of Saga warranty data, change in VIN range, and reformatting

RVU - Update Programming For Catalytic Converter System (IC)

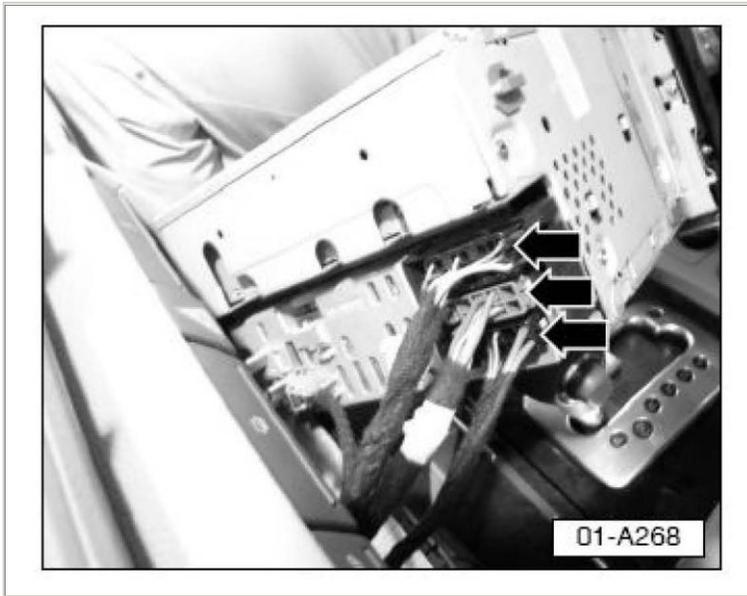
3. Disconnect all electrical connectors (arrows) from multi-pin connections.
4. With VAS 5051/5052 connected to the DLC using the VAS 6017A or B adapter, select Vehicle Self Diagnosis mode.

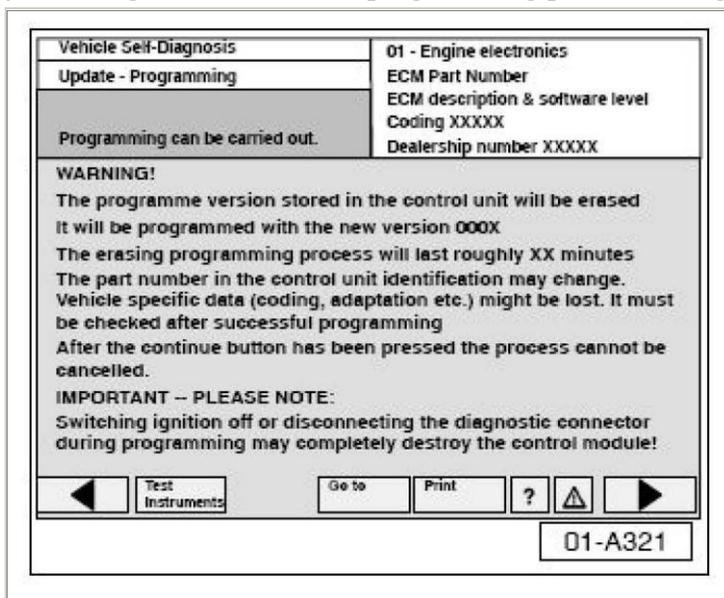
1. Select Update - Programming option at bottom of screen (arrow).

After selecting Update - Programming function, new software level 0050 is indicated along with approximate timing for update.

2. By selecting the > button, the programming procedure begins.

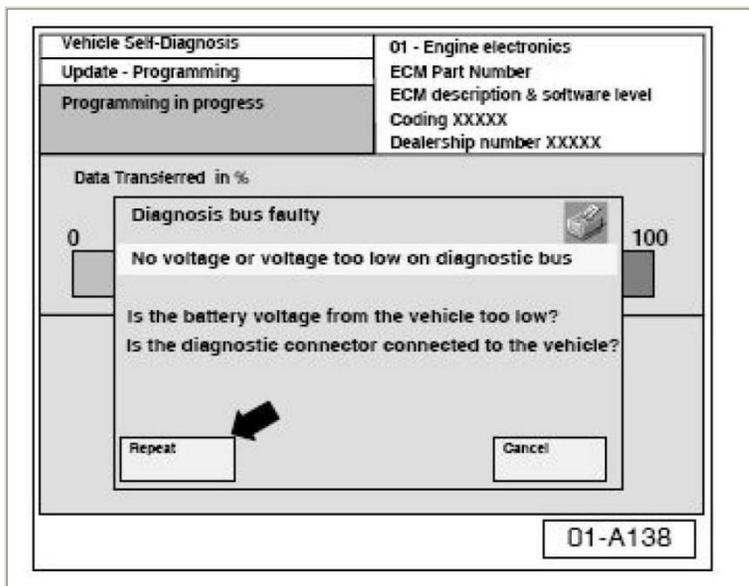
3. If, during the Update - Programming, a fault message is displayed:
 - a. Confirm that VAS 5051 or VAS 5052 diagnostic tool power supply is adequate and that all appliances with high electromagnetic radiation (i.e. mobile phones) are switched off.
 - b. The Update - Programming (flashing) process must then be started from the beginning.

4. Restart the reflash using the Repeat button (arrow). Do not use the Cancel button.
Tip: Do not exchange the Update - CD when the Update - Programming procedure fails after it has started.
5. Once Update - Programming (flashing) is complete, the Control Module must be re-initialized.
6. The tester requests you to switch the ignition off. Switch ignition off.
7. Disconnect VAS 5051 or VAS 5052.
8. Connect all electrical connectors to multi-pin connections.
