2012357/3

December 22, 2008.

Supersedes Technical Service Bulletin Group 01 number 06-14 dated August 22, 2006 for reasons listed below.

01 Malfunction Indicator Light (MIL) ON, DTC P0421 or P0431 Stored in DTC Memory

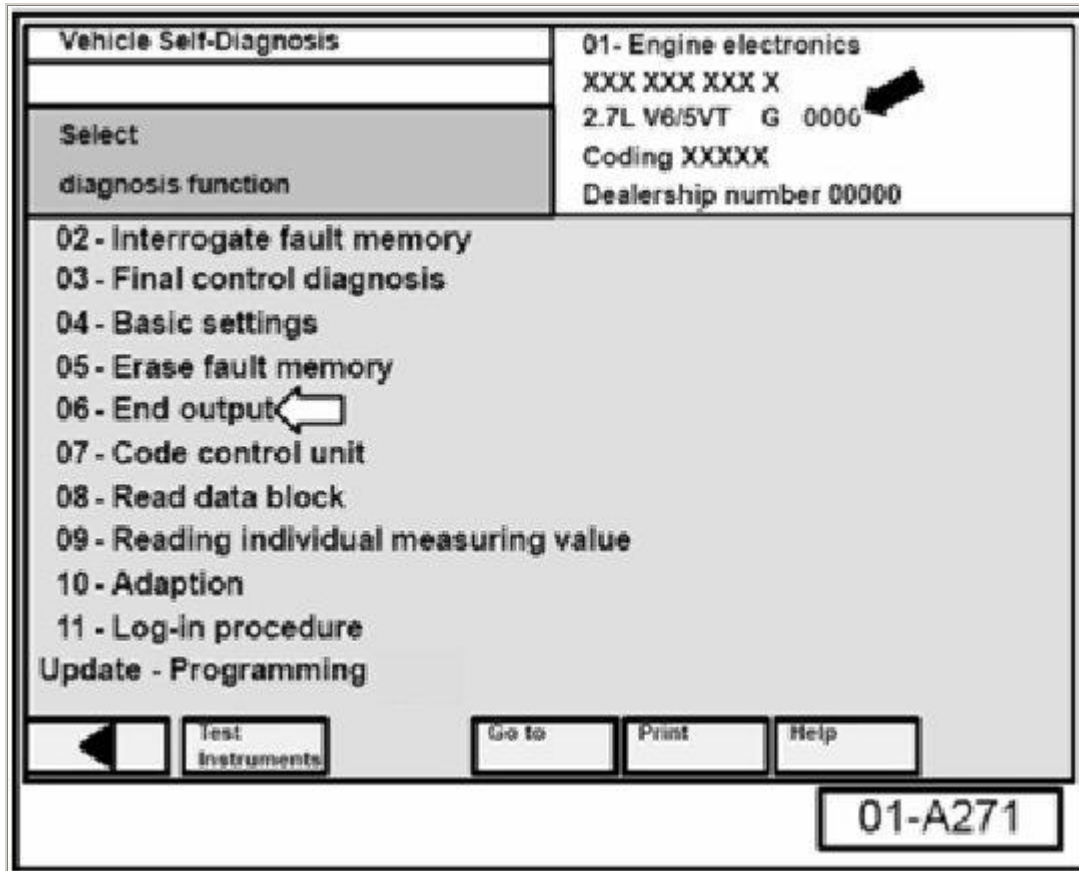
If ECM software level (black arrow) is 4000 or higher:

If ECM software level is lower than 4000:

Print screen and attach printout to the repair order.

- Do not complete this Technical Bulletin.
- Select: 06 End Output (white arrow).
- Replace affected Catalyst.

Before starting the Update-Programming procedure, the fault memories of all systems need to be interrogated and existing DTC's need to be printed and erased.

- Select backward button to return to Start Screen.
- Select: Vehicle Self Diagnosis >> 00 - Collection Services >> Check DTC Memory - Complete System, which will interrogate all fault memories.

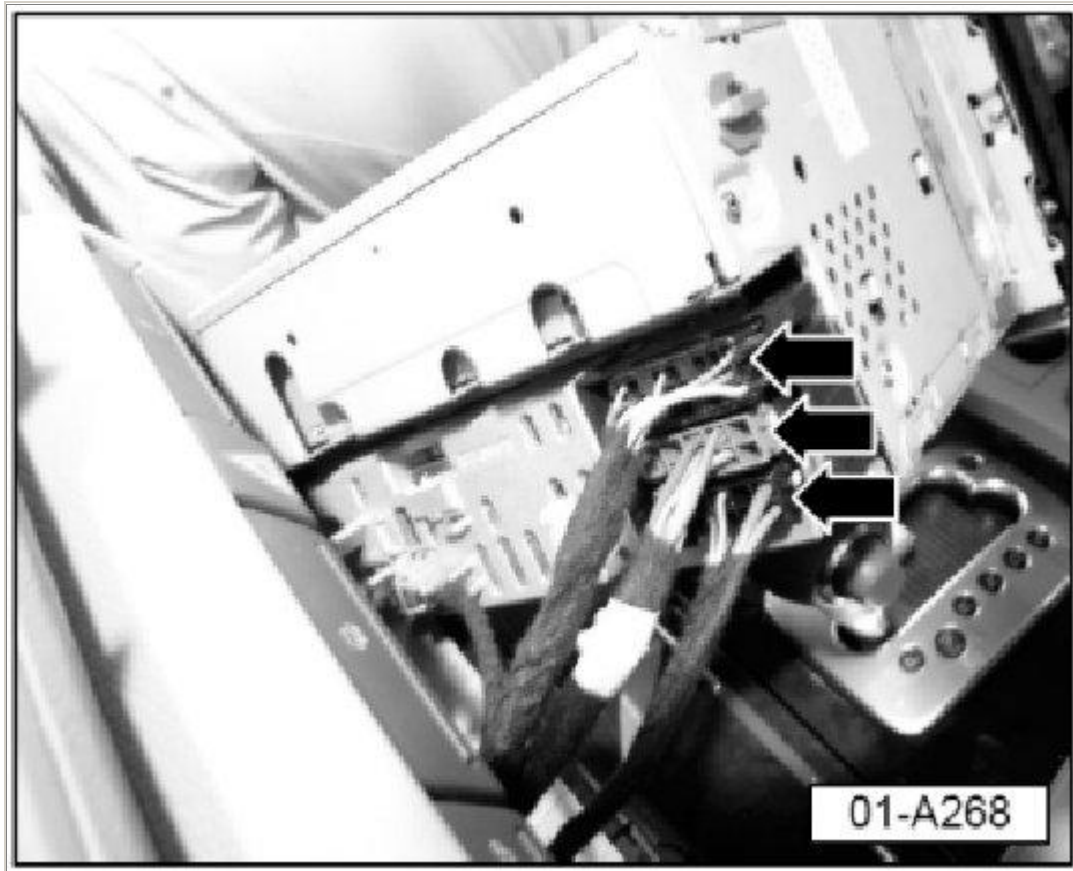
Before starting the Update-Programming Procedure, the radio needs to be disconnected from the electrical system.

- Switch ignition OFF.
 - Access and record radio code.
 - Pull radio out from instrument panel enough to access electrical connectors.
 - Disconnect all electrical connectors (arrows) from multi-pin connections.
 - Switch ignition ON.
2. Update - Programming (flashing) performing

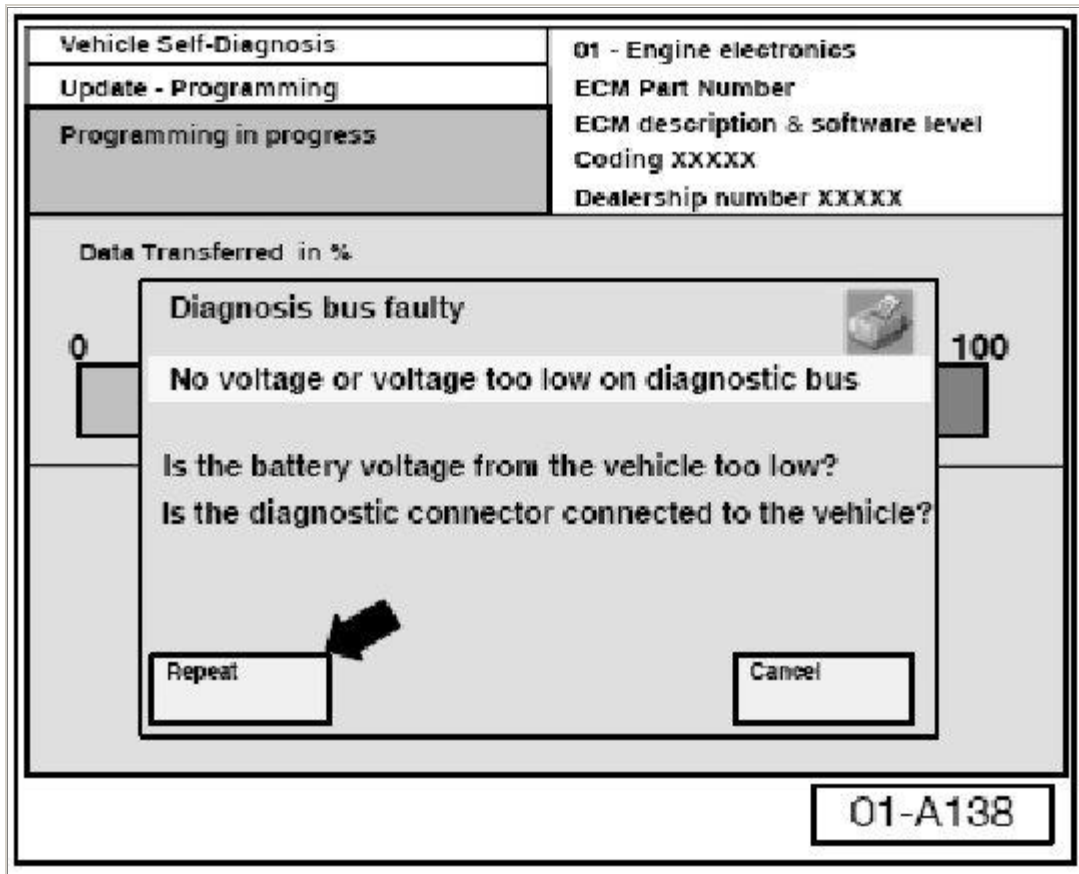
If, during the "Update - Programming", this fault message is displayed:

- Select "Repeat" button (arrow) and the "Update Programming process" will be started from the beginning.
- DO NOT select the "Cancel" button! DO NOT switch OFF the ignition!
- Confirm that VAS 5051/5052 diagnostic tool power supply is adequate and that ALL appliances with high electromagnetic radiation (i.e. mobile phones) are switched OFF.

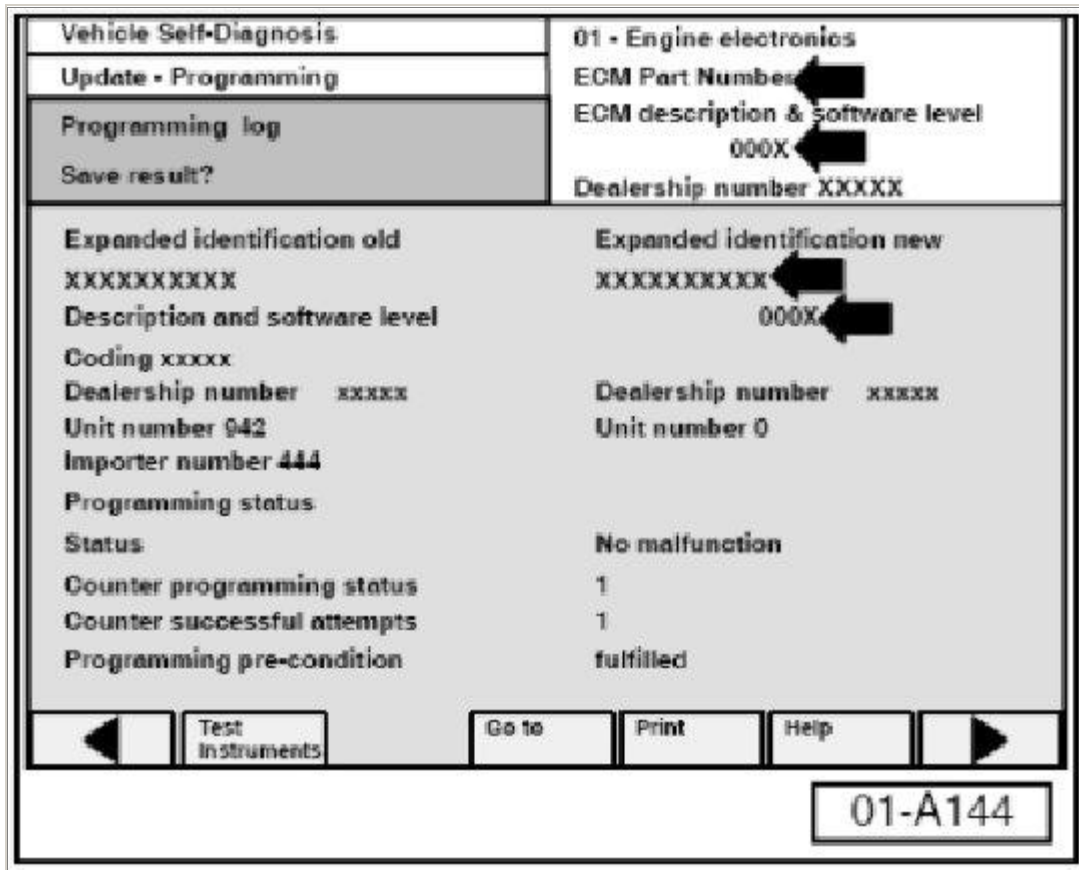
Similar Screen appears, once "Update Programming" (flashing) is complete:

Old ECM Part No. and software level are still displayed on the screen (arrows). New ECM Part No. and software level are not displayed until process is complete and fault memories have been erased.

- Print screen and attach printout to the repair order.
- Select forward button

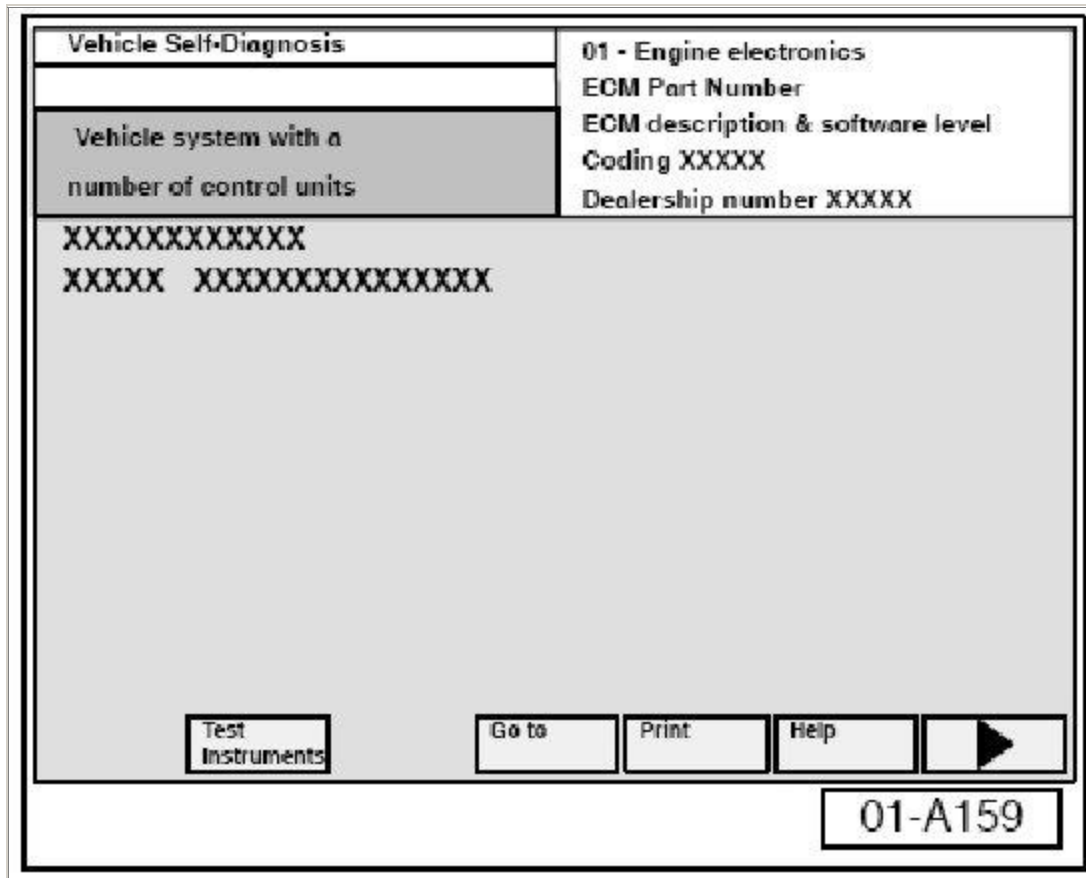
Updated software level 4000 will appear.

- Print screen and attach printout to the repair order.
- Select "Go to" >> "Exit" to return to Start Screen.
