## TechNote

SI B 12 04 00

SUBJECT

Secondary Air System Faults

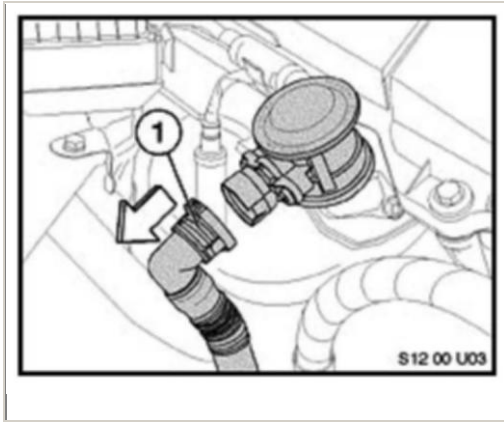
Disconnect the air pump feed line/hose (1) at the non-return valve (line from the secondary air pump

to the non-return valve).

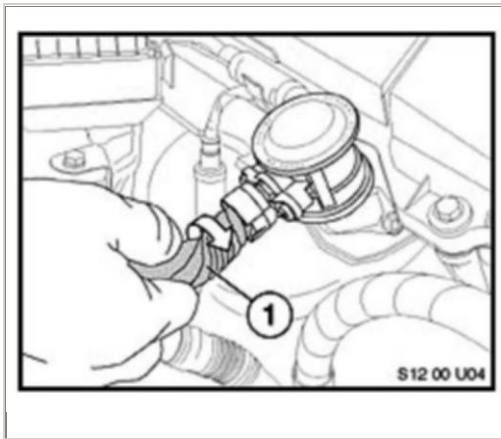
Visually inspect the non-return valve fitting internally for carbon type contamination. (Twisting the corner of a clean shop rag into the valve fitting as shown will assist with this check.)

If no carbon type deposits are found on the rag, this indicates that the non-return valve is sealing correctly and does not need to be replaced.

If carbon type deposits are found on the rag, the non-return valve is not sealing correctly and must be replaced.

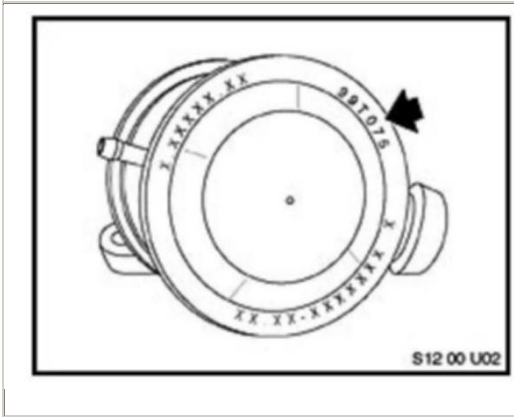
A Non-return valve with a dated code stamping as of 99T075 (arrow) and later is the improved version. date cose explanation: 99=year, T=day, 075=75th day of the year.

Only the improved non-return valves are available from the Parts Distribution Centers.
