#PIP5029G: Rough Idle Crank No Start Extended Crank Or Misfire Due to Excessive Carbon On Top of the Valves or Sticking Valves - (Sep 9, 2016)

Models: 2000-2015 All Passenger Cars with Gasoline Engines
2000-2015 All Light Duty Trucks with Gasoline Engines

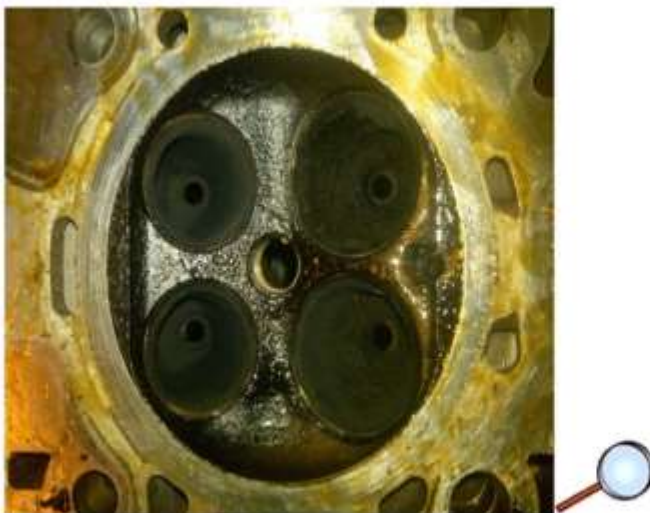
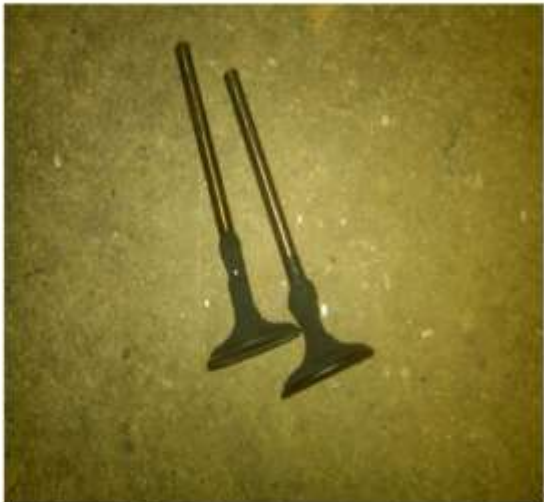
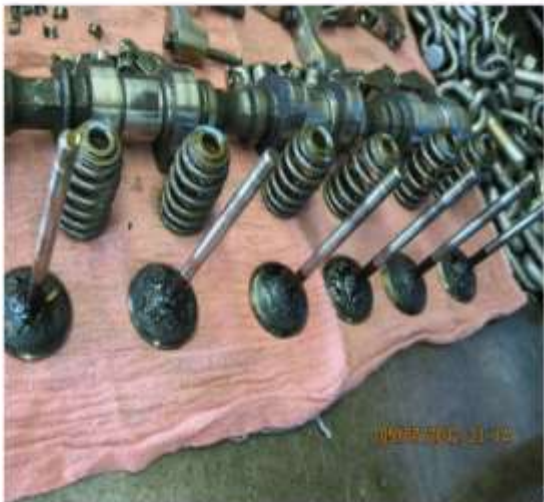
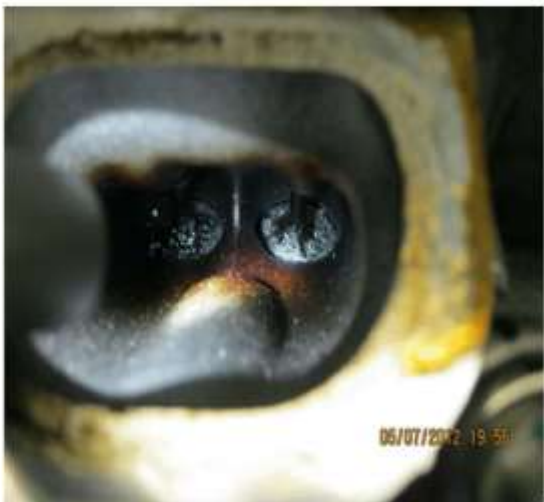
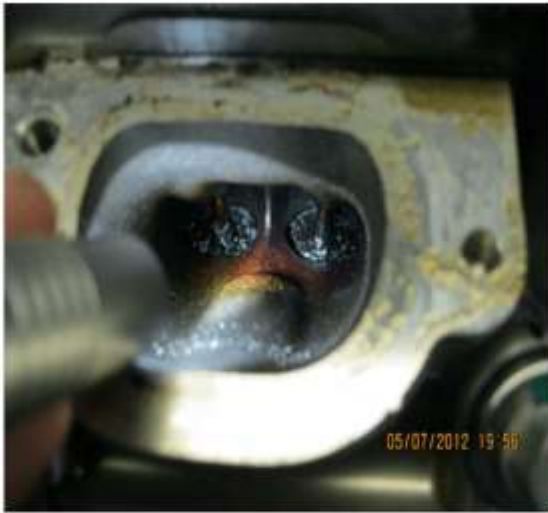
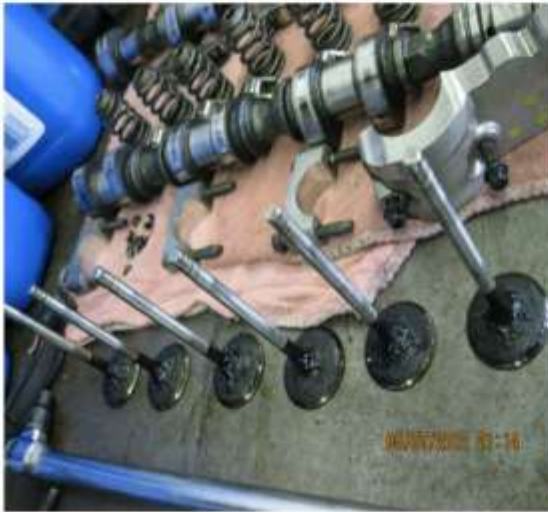
This may be the result of major carbon build up on the intake and/or exhaust valves due to fuel contamination or incomplete burning of the fuel as shown below so the misfires should not have appeared until accumulating at least 5,000 miles or more.

When the engine is cold, the compression on multiple cylinders may be at 0 PSI.

The engine also may pop through the intake or exhaust while cranking and the spark plugs may be fuel fouled when inspected.

Some engines may also experience valve damage or cam followers that are out of position as a result of this.

If there is no sign of valve damage or cam followers that are out of place, perform the following procedure to free up sticking valves and to remove carbon from the valves and pistons.

Perform an upper engine and valve cleaning procedure as outlined below.

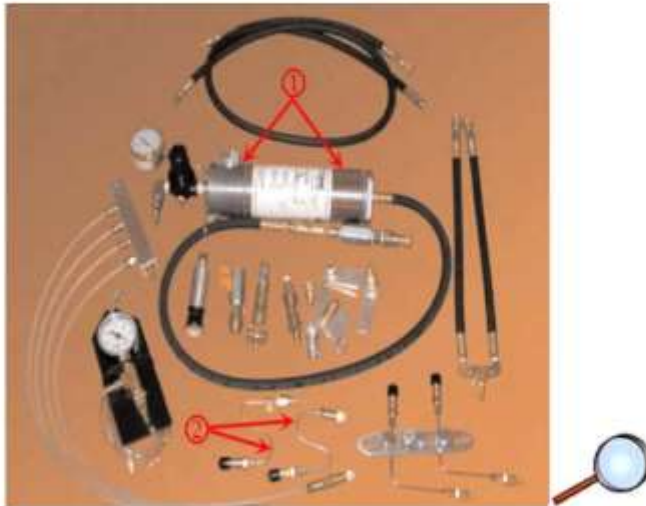
Kent Moore Tool Kit # J-45076

1. Pressurized Canister from J-45076 is Shown - J-35800-A is Similar (Equivalent Pressurized Canister Acceptable)
2. Throttle Body Cleaning Adapters J-45076-46 and J-45076-55 Shown (Equivalent Adapters Acceptable)
