Tech Notes:

1997-2001 Toyota Camry and Solara 2.2L 5SFE ENGINE

EVAP SYSTEM DIAGNOSIS: P0441 / P0446

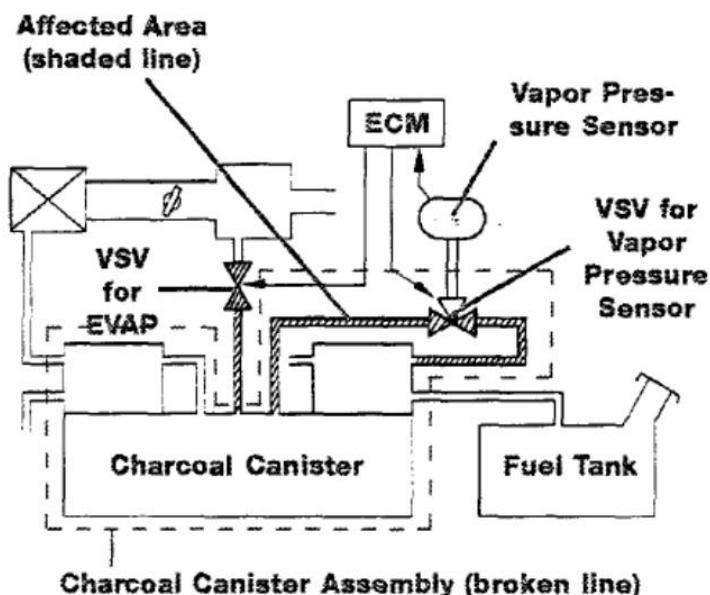
NOTE :When performing diagnostics for an occurrence of a MIL "ON" condition, Diagnostic Trouble Code (DTC) P0441 may be result of debris in Evaporative Emission Control System. This may cause blockage of a vapor line, or a stuck VSV, as described in troubleshooting area of Repair Manual.

1. Remove Vacuum Hoses between EVAP VSV and Charcoal Canister and discard.
2. If there is a metal vapor pipe between EVAP VSV and Charcoal Canister, clean inside of vapor pipe
3. Replace EVAP VSV and Charcoal Canister assembly with new parts.
4. Install new vacuum hoses between EVAP VSV and Charcoal Canister.

1. Inspect vacuum hoses and pipes between EVAP (Purge) VSV and Charcoal Canister for leaks.
2. Replace Vapor Pressure VSV and Canister.
