Diversified Environmental Catalysts

Tech-Note

M.I.L. "ON" DTC P0171 AND/OR P0174: ENGINE RUNNING LEAN

'04 Camry, Sienna & Solara (3MZ-FE)

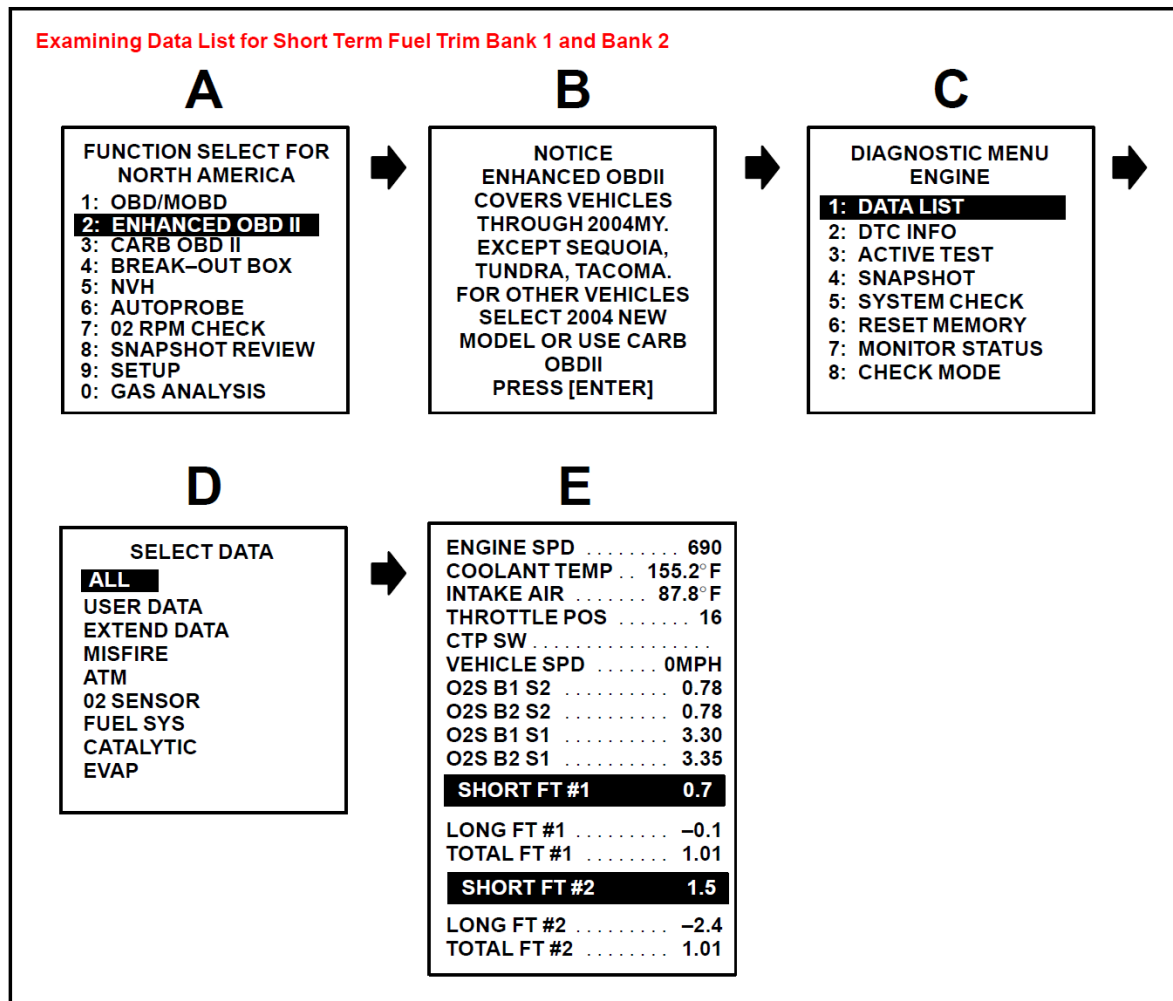
1. Monitor the Bank 1 and Bank 2 Short Term Fuel Trim in the Data List.

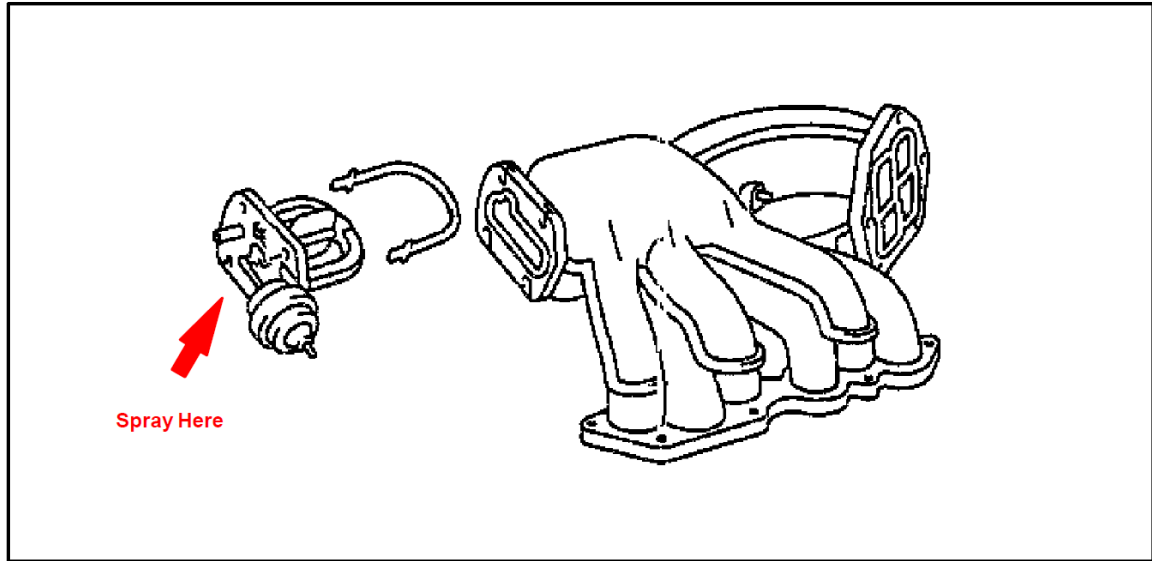
2. Spray carburetor cleaner near the Intake Air Control Valve pivot shaft and monitor Short Term Fuel Trim as indicated in step 1.

3. Was the short term fuel trim changing to a rich reading, or negative fuel trim in step 2?

If Yes – Replace the Intake Air Control Valve. Refer to the Technical Information System (TIS), 2004 model year applicable model Repair Manual: *Intake: Intake Air Control Valve Assy No. 2 (3MZ-FE): Replacement.*
