Tech Notes:

2001-2004 Subaru Outback 3.0L 6 cylinder engines

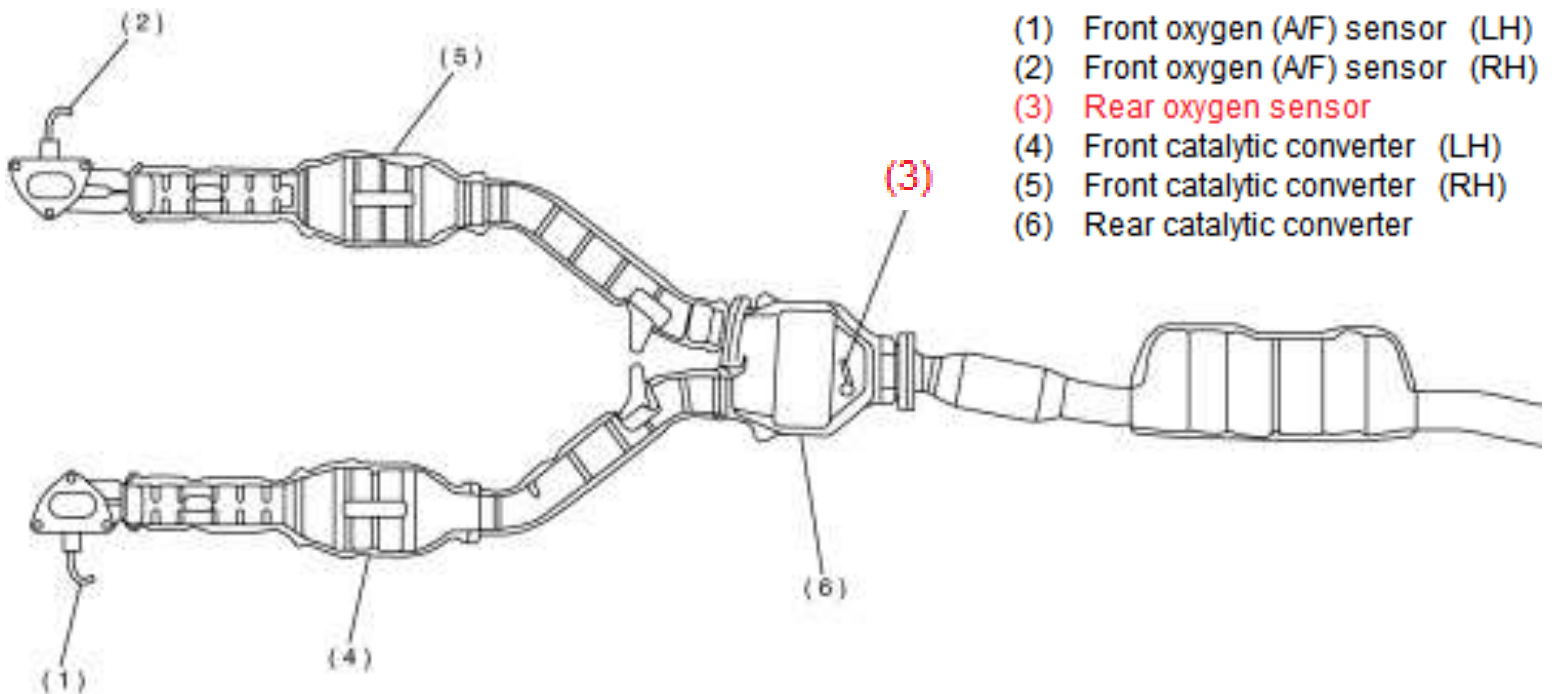
Be careful when replacing a catalytic converter on these vehicles due to a **P0420** code. As illustrated below, these cars have only 1 downstream O₂ sensor which monitors all three converters at once. While P0420 is the ONLY code these vehicles can set, the code in this case does NOT automatically mean “Bank #1”.

For a vehicle’s computer to be able to determine “Bank #1” or “Bank #2”, there must be an oxygen sensor behind each converter individually. In the case of these vehicles, there is no way for the PCM to make that distinction.
