## **Tech Note**

Service Campaign 83C:

Mass Air Flow (MAF) sensor connector

Volvo S70/V70/C70 Turbo versions.

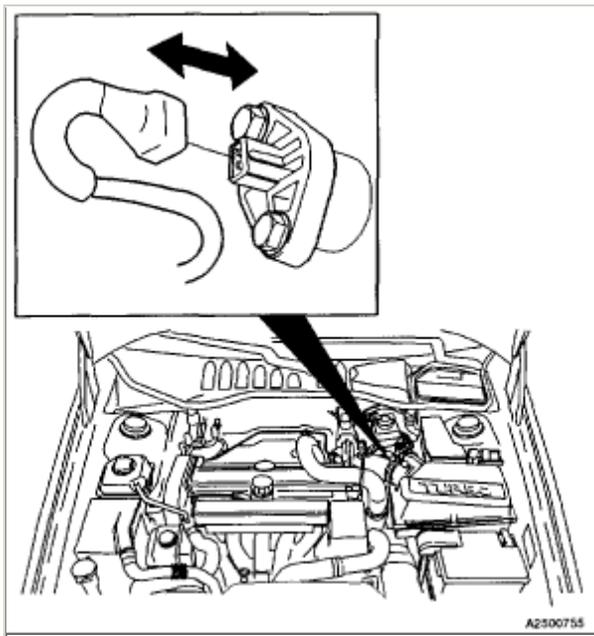
- Check that no terminals have been backed out of the connector and they are undamaged.

- Disconnect connector
- Disconnect/connect connector 3 times to remove oxide layer on the mating surface.

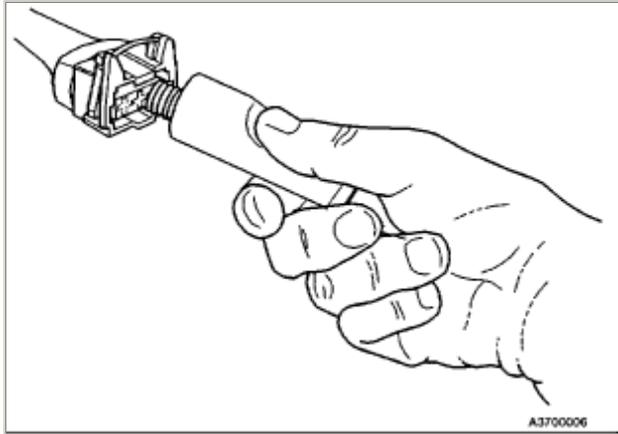
Lubricate the connector

Check terminals if they are greased.

Add grease only if it is missing.

Use low temperature grease. 0.5 gram/car. Make sure that no dirt is introduced with the grease.

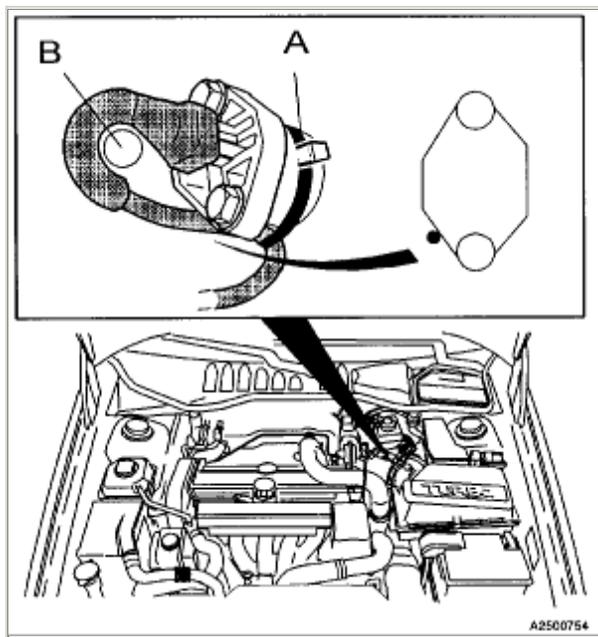
Secure the cable harness to the mass air flow (MAF) sensor

If the cable is stretched, position cable on the other side of the turbocharger control valve (TCV) hoses which are under the MAF sensor.

Position cable with an 18 mm (23/32") diameter loop (B), so that it is not putting stress on the connector (check with calipers).

Hold the cable in the position it is to be fixed and check that the cable is not stretched.

Install tie strap (A) (P/N 948211-8) as illustrated.
