## Tech-Note

## Engine – MIL ON/DTC's P0171/P0174 Set

Bulletin No.: 02-06-01-016A

(MIL) SERVICE ENGINE SOON Telltale Illuminated With DTCS P0171 and/or P0174 (Retorque Intake Manifold Vacuum Chamber Bolts, Install Vacuum Chamber Springs)

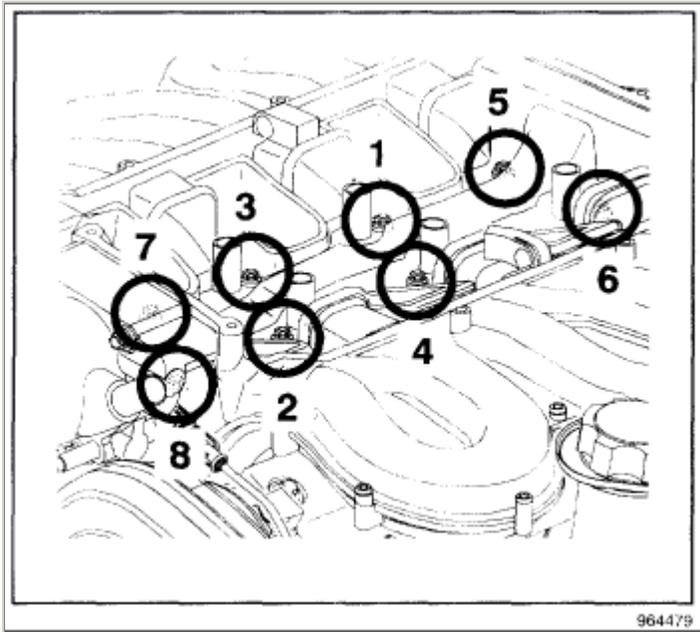
This condition may be caused by insufficient torque on the intake manifold vacuum chamber bolts. Under deceleration, enough vacuum can be created inside the intake manifold to lift the vacuum chamber off its seal creating an intermittent vacuum leak.

5. Remove 16 (10 around outside, 6 on inside) intake manifold top cover bolts and cover.
6. Remove vacuum chamber and apply Loctite(TM) 242, P/N 21485277 (in Canada, P/N 12345382), or equivalent, to the bolts and reinstall.
