Tech Note

Group 11
Engine
Bulletin Number
11 04 97
Woodcliff, NJ
November 1997
Product Engineering

Intake Air System - Unmetered Air Leaks

E39, E38, E31 with M62 engine

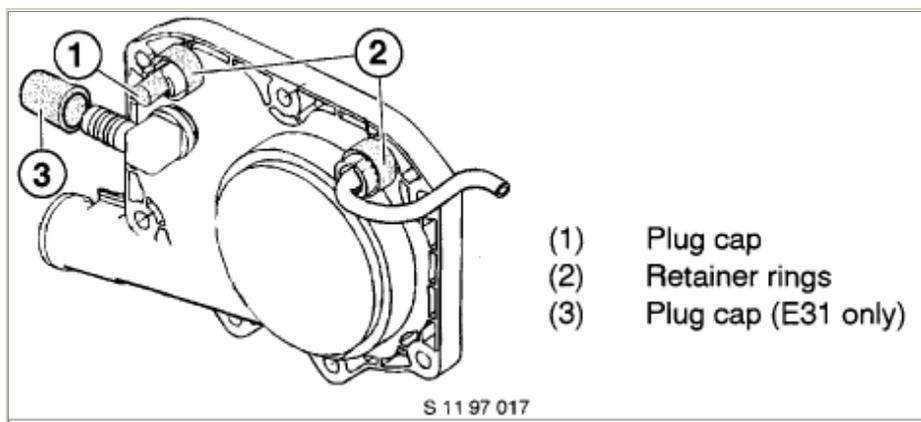
1. Intake manifold gaskets may be leaking.
2. Plug cap(s) and the vacuum hose for the fuel pressure regulator on the rear intake manifold cover (crankcase ventilation valve) may be torn or missing.

In addition the plug caps (1) and (3)-E31 only) on the rear intake manifold cover should also be replaced and new retainer rings (2) installed as shown in the illustration.

New style plug caps and retainer rings were phased into production approximately 10197 on all M62 engines. If the retainer rings (2) are already present on the rear intake manifold cover, this indicates the new style plug caps are also already installed.
