26 07 01

Supersedes Technical Service Bulletin Group 26 number 05-03 dated July 20, 2005 due to addition of Saga warranty data, change in VIN range, and reformatting

RVU - Update Programming For Catalytic Converter System (IC)

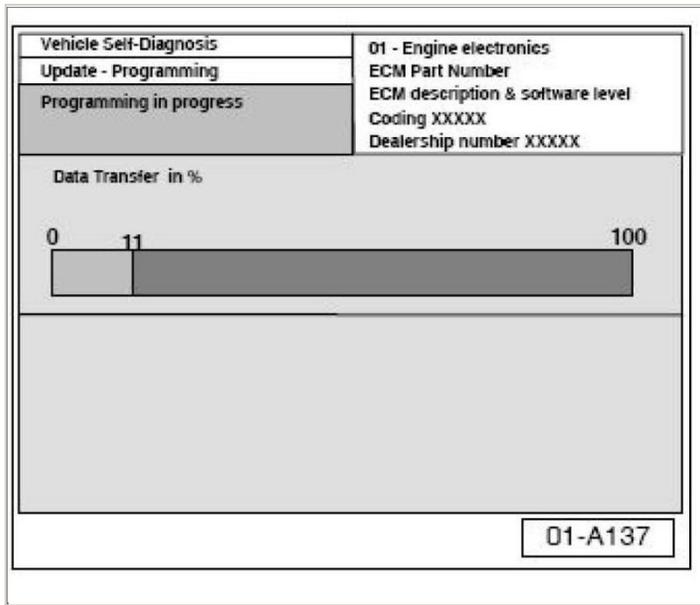
A data transfer screen appears. The previous data in the ECM is erased, and the new data is being transferred to the module from the flash CD.

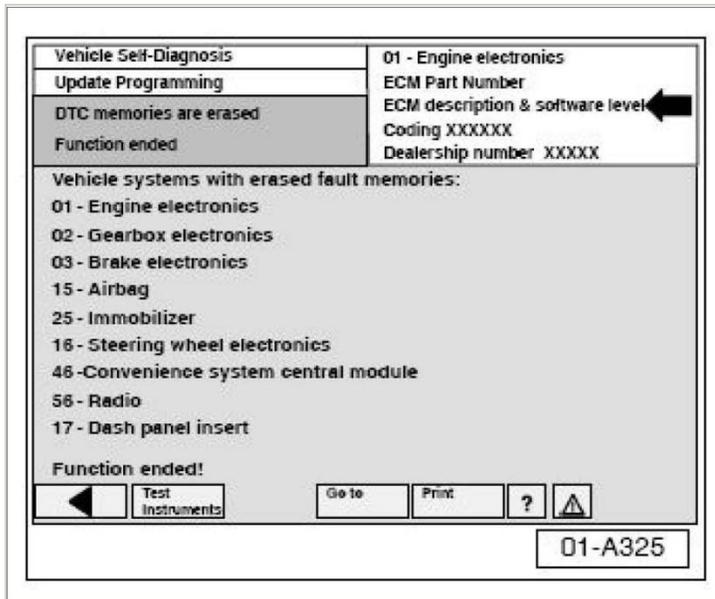
^ Function ended! appears at bottom of screen.
