Technical Service Bulletin

2012 Infiniti Truck QX56 AWD V8-5.6L (VK56VD)

- Engine Controls - MIL ON, DTC's P0420/P0430 Set

2011 - 2012 QX56; MIL "ON" WITH DTC P0420 AND/OR P0430

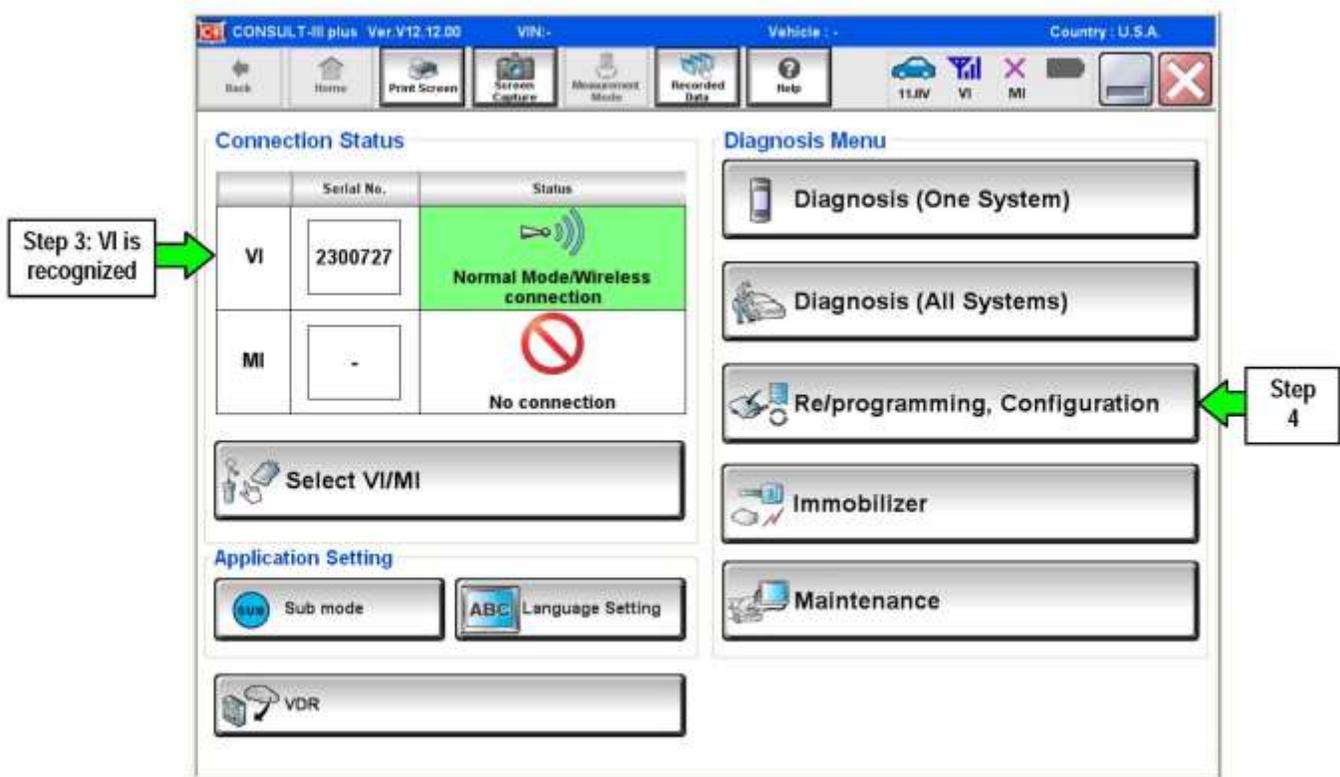
Figure 1

1. Connect the CONSULT PC to the vehicle to begin the reprogramming procedure.
2. Open / start C-III plus.

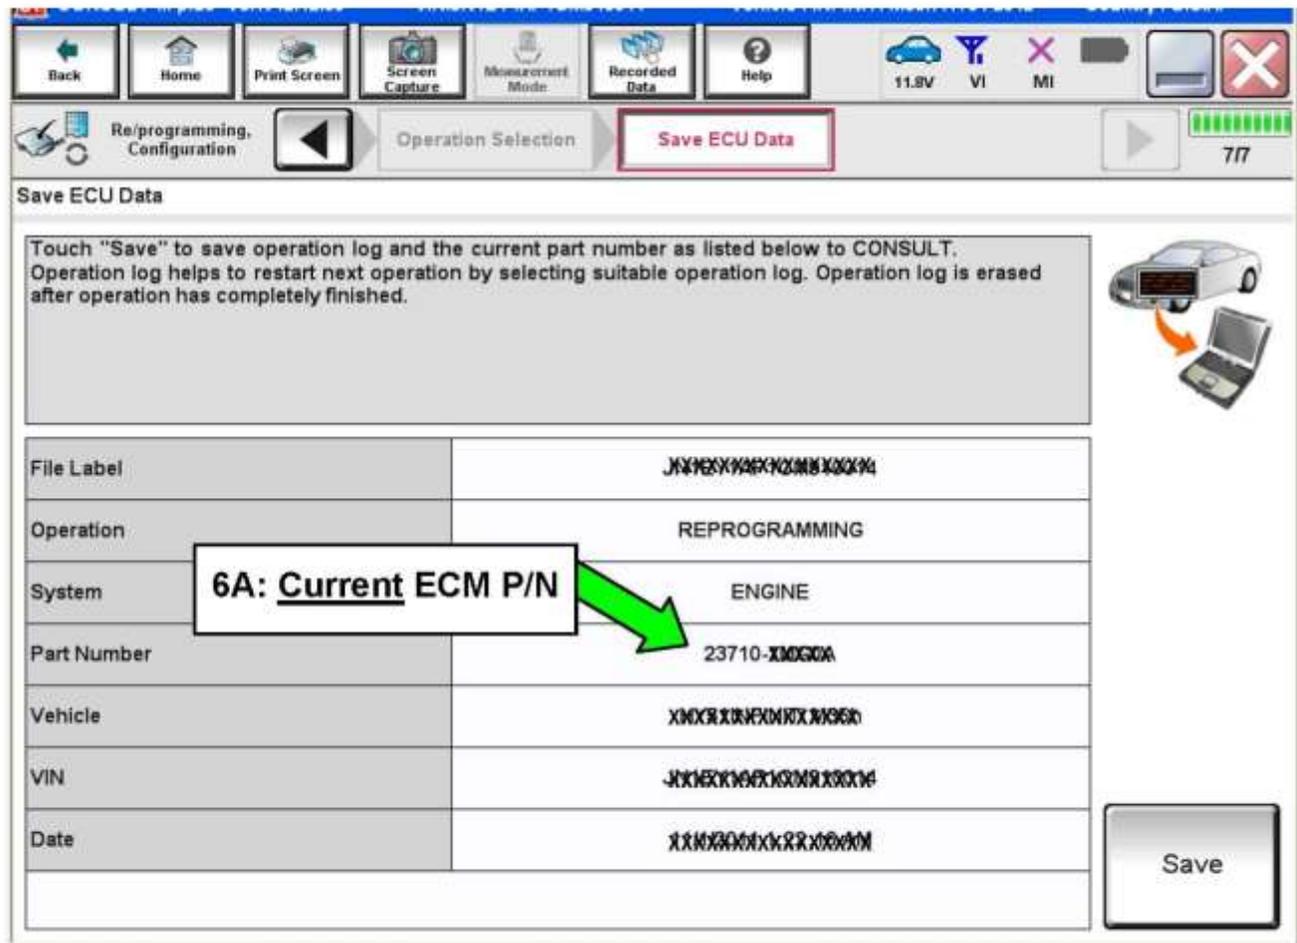
Figure 2

NOTE: This is the current ECM Part Number (P/N).

5. Follow the on-screen instructions and navigate the C-III plus to the screen shown in Figure 2.
6. When you get to the screen shown in Figure 2, confirm this bulletin applies as follows.
 - A. Find the ECM Part Number and write it on the repair order.

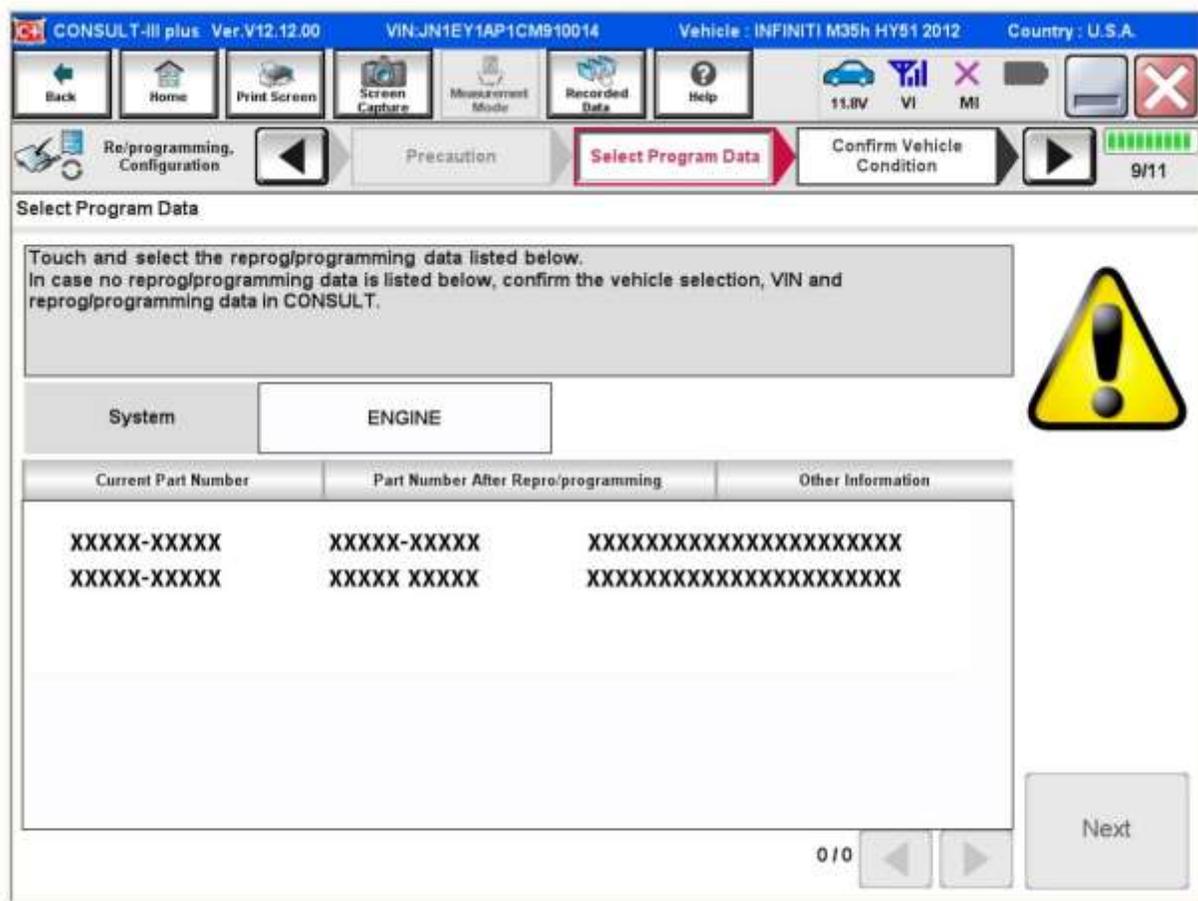
- In some cases, more than one new P/N for reprogramming is available.
 - If more than one new P/N is available, the screen in Figure 3 displays.
 - Select and use the reprogramming option that **does not** have the message "Caution! Use ONLY with ITBXX-XXX".
- If you get this screen and it is blank (no reprogramming listed), it means there is no reprogramming available for this vehicle. Close C-III plus and refer back to ASIST for further diagnosis.

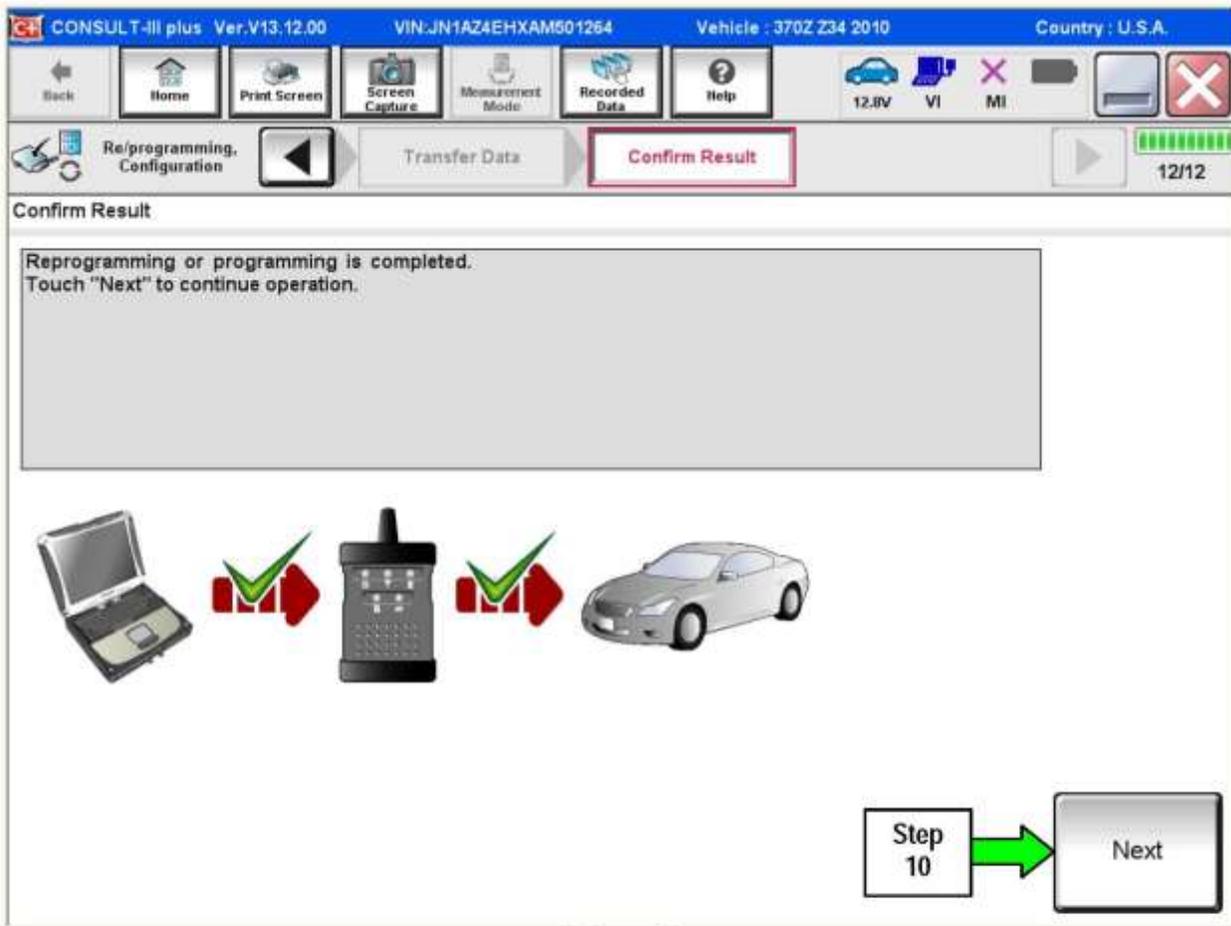
8. When the screen in Figure 4 displays, reprogramming is complete.

If the screen in Figure 4 does not display (reprogramming does not complete), refer to ECM recovery.

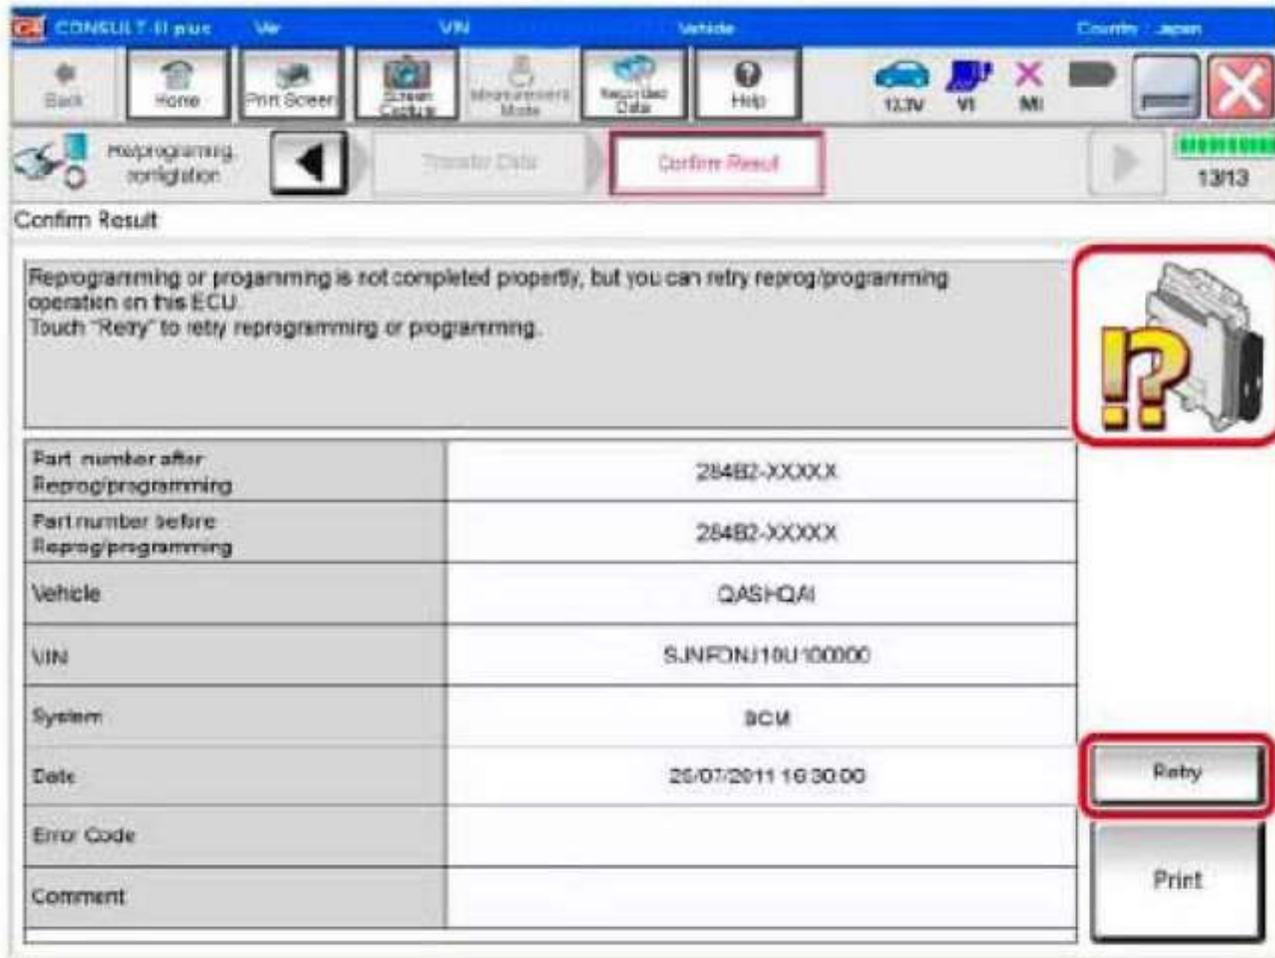
Figure 5

If reprogramming does not complete and the "!" icon displays as shown in Figure 5:

- ^ Check battery voltage (12.0 - 15.5 V).
- ^ Ignition is ON, engine OFF.
- ^ External Bluetooth(R) devices are OFF.
- ^ All electrical loads are OFF.
- ^ Select retry and follow the on screen instructions.
- ^ "Retry" may not go through on first attempt and can be selected more than once.

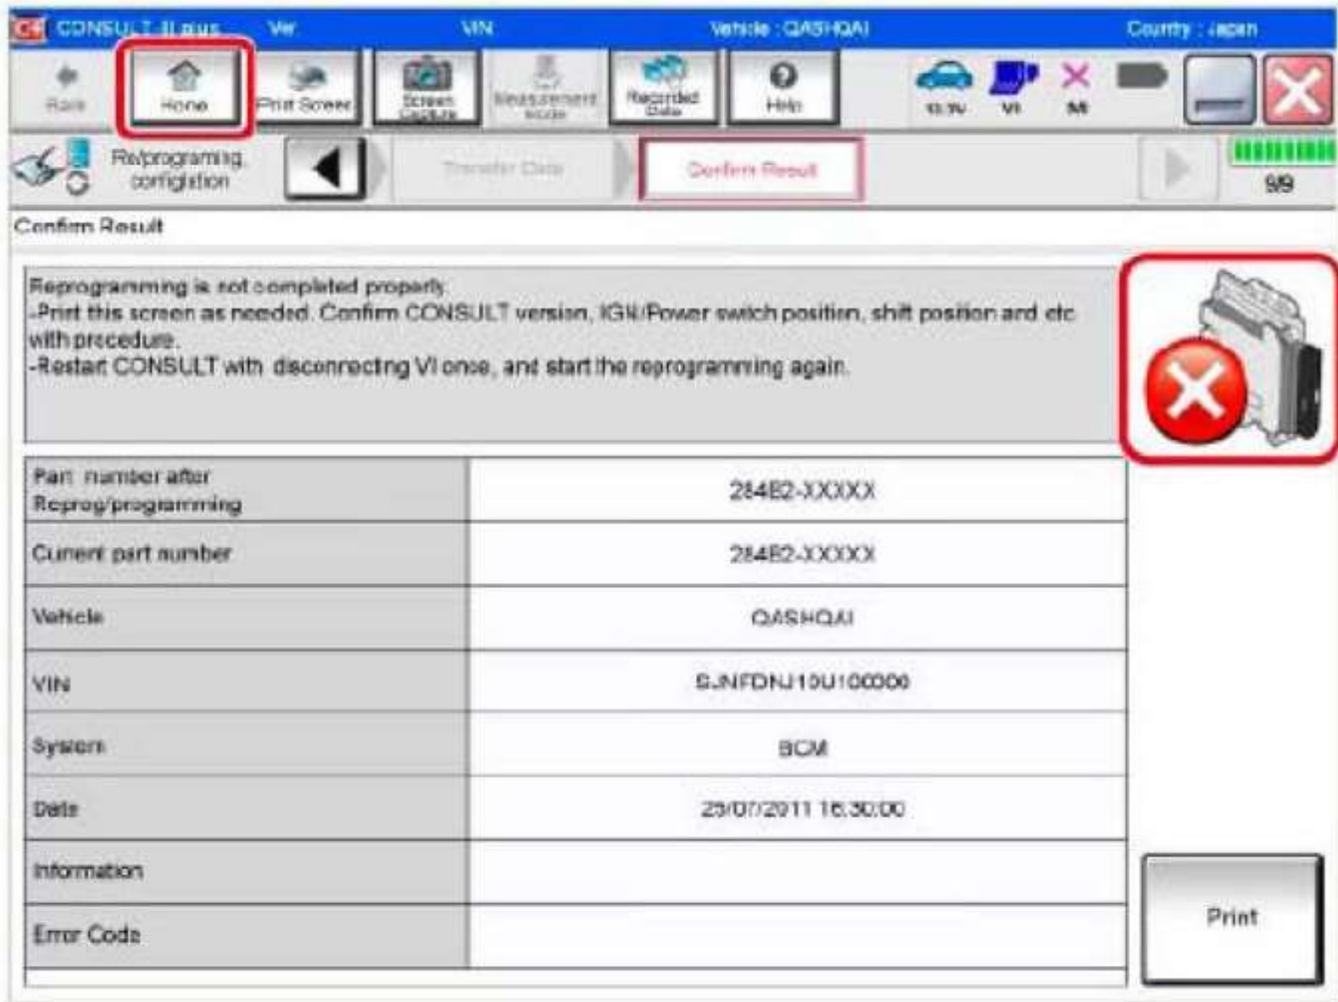
Figure 6

If reprogramming does not complete and the "X" icon displays as shown in Figure 6:

- ^ Check battery voltage (12.0 - 15.5 V).
- ^ CONSULT A/C adapter is plugged in.
- ^ Ignition is ON, engine OFF.
- ^ Transmission is in Park.
- ^ All C-III plus / VI cables are securely connected.
- ^ All C-III plus updates are installed.
- ^ Select Home, and restart the reprogram procedure from the beginning.

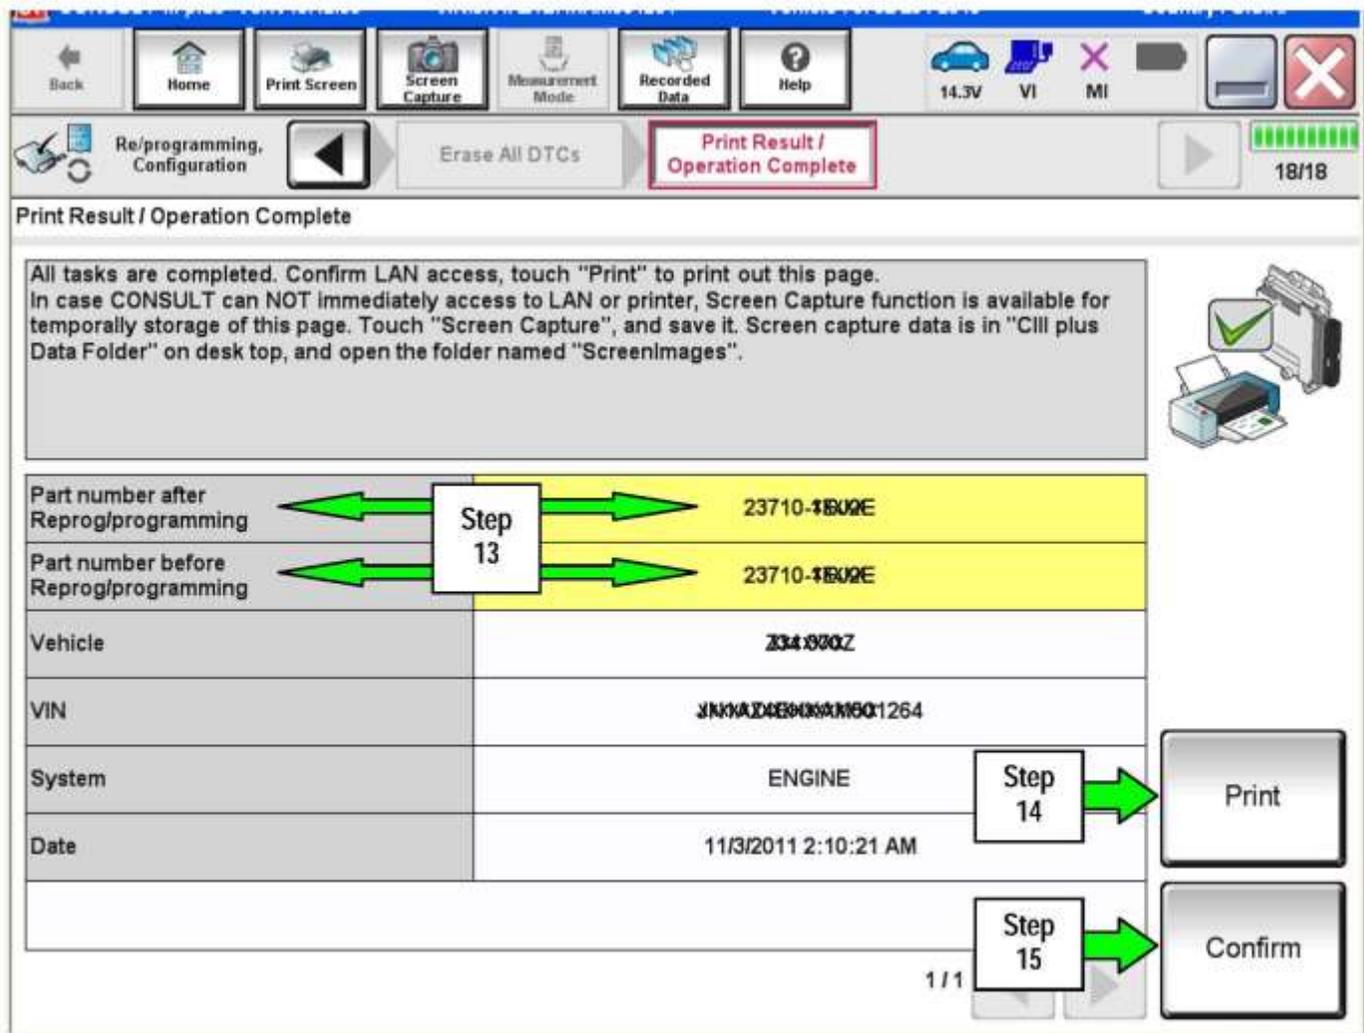
12. When the entire reprogramming process is complete, the screen in Figure 7 will display.
13. Verify the before and after part numbers are different.
14. Print a copy of this screen (Figure 7) and attach it to the repair order for warranty documentation.
15. Select Confirm.
